**Flood Control Project Maintenance
Levee Inspections****LMA District Cover Sheet****Spring 2012 Levee Inspection Results****Sacramento Maintenance Yard Willow Slough Bypass**

Levee Inspection Report By Mile - Spring 2012

Sacramento Maintenance Yard Willow Slough Bypass

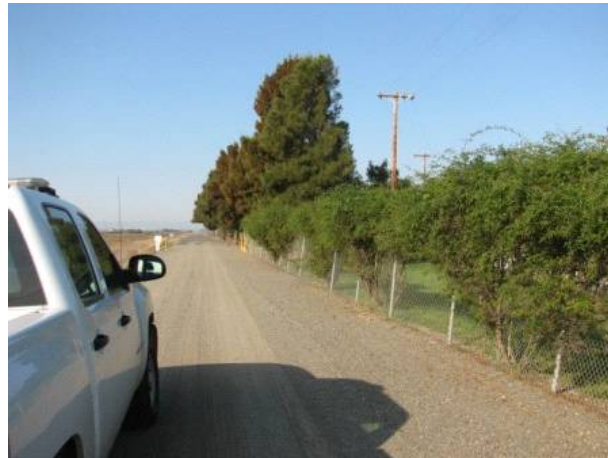
johngw_s_20120313_567.jpg

Levee Mile Report Line	4
Start Levee Mile	0.02
End Levee Mile	0.15
Location	Crown
Category	Earthen Levee
Item	Vegetation

The treatment plant's landscape and fence. This runs along the crown and toe of the levee.

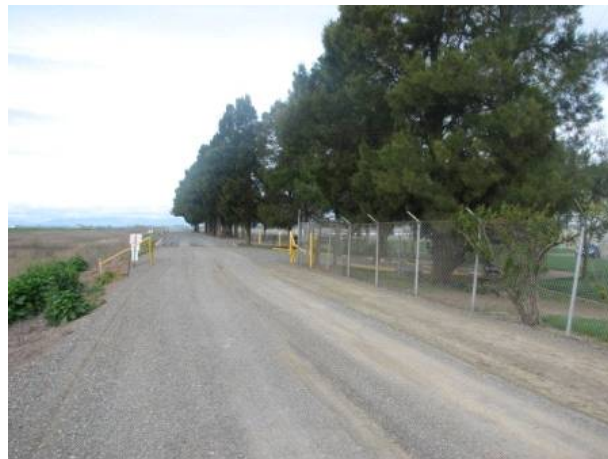
johngw_s_20120326_594.jpg

Levee Mile Report Line	4
Start Levee Mile	0.02
End Levee Mile	0.15
Location	Crown
Category	Earthen Levee
Item	Vegetation

Photo taken spring 2012, the treatment plants landscaping.

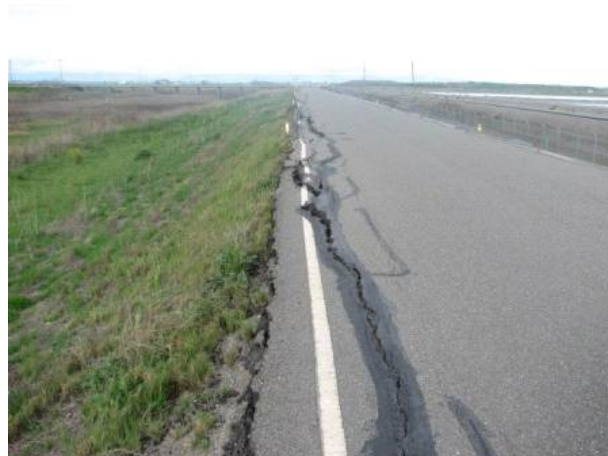
johngw_s_20120326_595.jpg

Levee Mile Report Line	5
Start Levee Mile	0.34
End Levee Mile	0.36
Location	Water Side
Category	Earthen Levee
Item	Cracking

Photo taken spring 2012, cracking along the waterside shoulder.

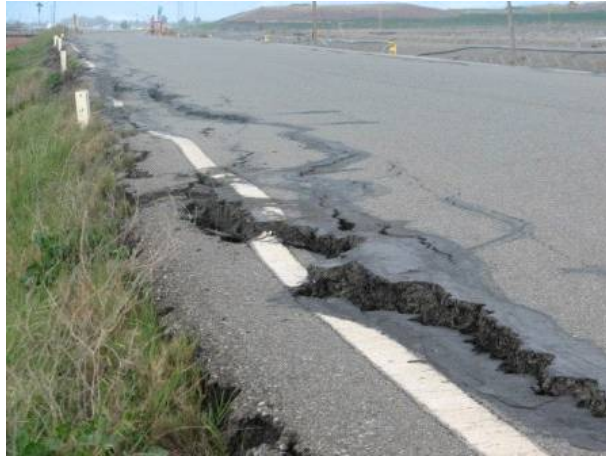
johngw_s_20120326_596.jpg

Levee Mile Report Line	5
Start Levee Mile	0.34
End Levee Mile	0.36
Location	Water Side
Category	Earthen Levee
Item	Cracking

Photo taken 2012, the shoulder has fallen 4"-6" in depth.

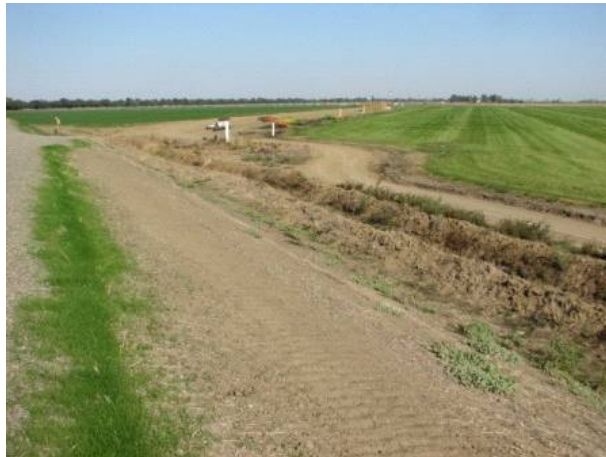
johngw_s_20120313_568.jpg

Levee Mile Report Line	6
Start Levee Mile	4.16
End Levee Mile	4.63
Location	Land Side
Category	Earthen Levee
Item	Encroachments

The agricultural ditch runs along the toe of the levee. Fall 2011

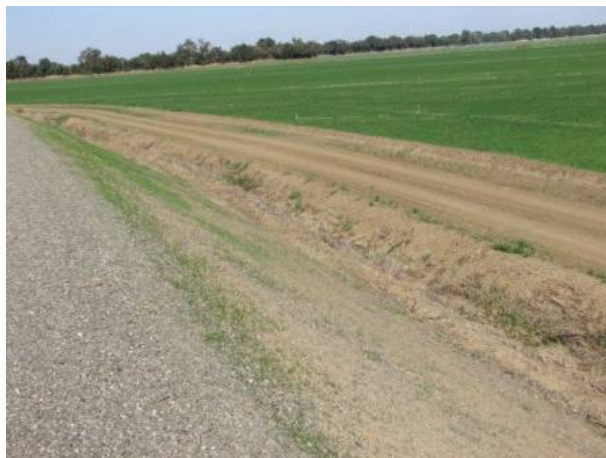
johngw_s_20120313_569.jpg

Levee Mile Report Line	6
Start Levee Mile	4.16
End Levee Mile	4.63
Location	Land Side
Category	Earthen Levee
Item	Encroachments

Another view of the agricultural running along the toe of the levee. Fall 2011

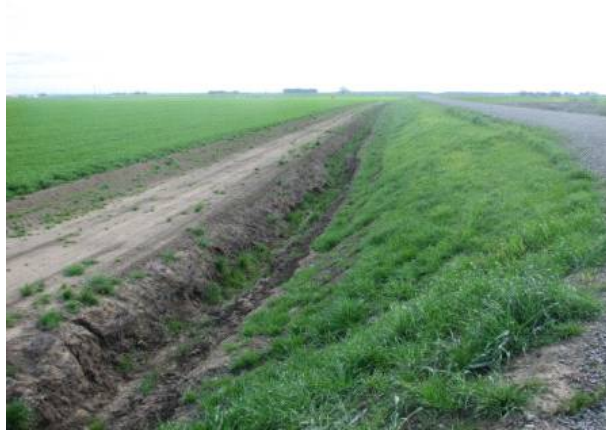
johngw_s_20120326_599.jpg

Levee Mile Report Line	6
Start Levee Mile	4.16
End Levee Mile	4.63
Location	Land Side
Category	Earthen Levee
Item	Encroachments

Photo take spring 2012, agricultural ditch along landside toe.

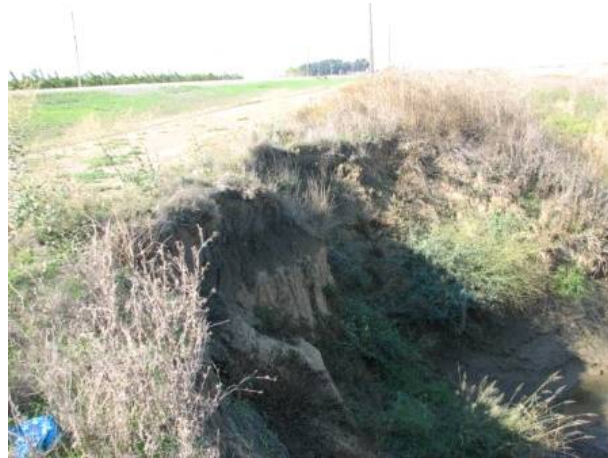
johngw_s_20120313_575.jpg

Levee Mile Report Line	3
Start Levee Mile	1.71
End Levee Mile	1.71
Location	Water Side
Category	Earthen Levee
Item	Erosion / Bank Caving

The erosion on the levee channel is encroaching into the toe road. Fall 2011

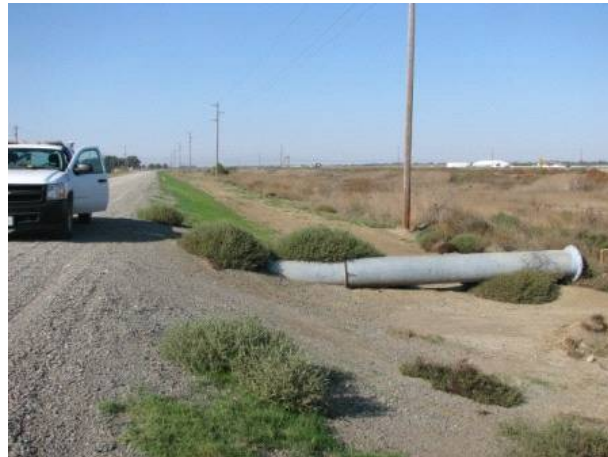
johngw_s_20120313_570.jpg

Levee Mile Report Line	4
Start Levee Mile	1.86
End Levee Mile	1.86
Location	Water Side
Category	Earthen Levee
Item	Encroachments

A pipe crossing thru the levee and blocking toe road. Fall 2011

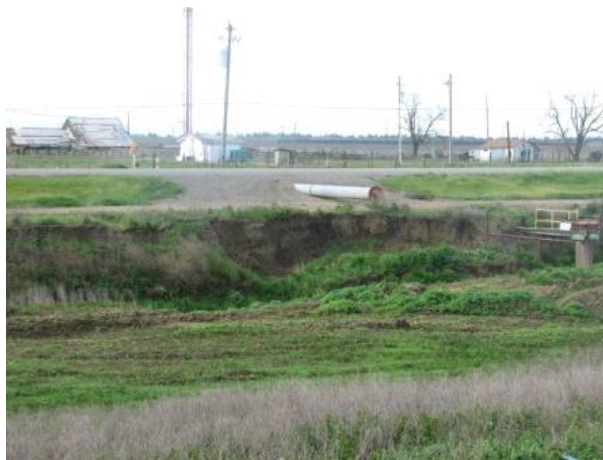
Levee Mile Report Line	5
Start Levee Mile	1.86
End Levee Mile	1.86
Location	Water Side
Category	Earthen Levee
Item	Erosion / Bank Caving
Photo taken spring 2012. the erosion increased very little over the winter.	
johngw_s_20120326_602.jpg

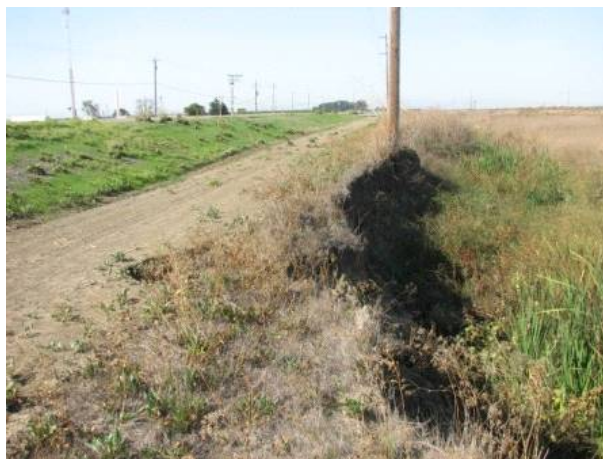
Levee Mile Report Line	6
Start Levee Mile	1.97
End Levee Mile	1.97
Location	Water Side
Category	Earthen Levee
Item	Erosion / Bank Caving
The erosion on the bank of the channel is encroaching into the power pole and toe road. Fall 2011	
johngw_s_20120313_573.jpg

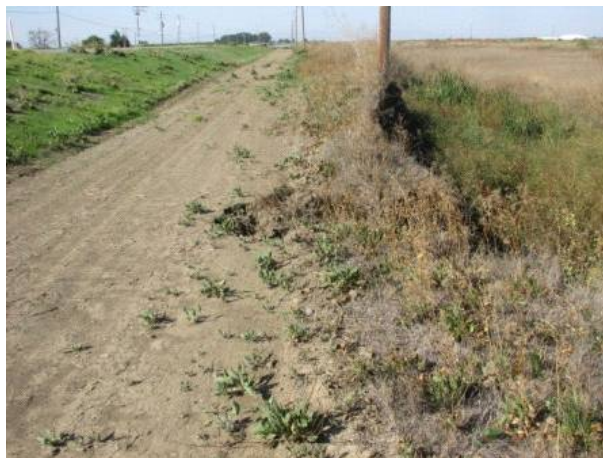
Levee Mile Report Line	6
Start Levee Mile	1.97
End Levee Mile	1.97
Location	Water Side
Category	Earthen Levee
Item	Erosion / Bank Caving
The erosion is starting to encroach into the toe road. Fall 2011	
johngw_s_20120313_574.jpg

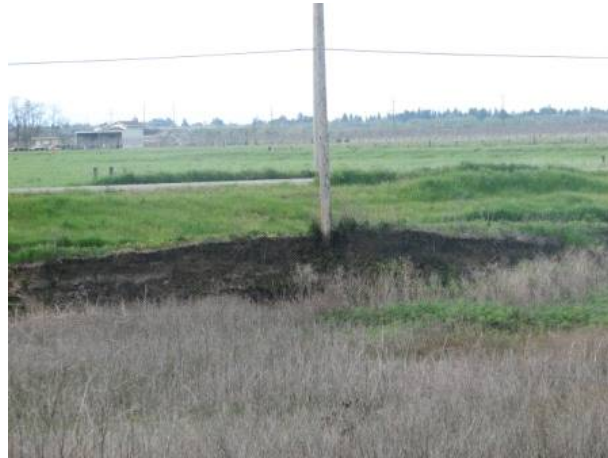
Levee Mile Report Line	6
Start Levee Mile	1.97
End Levee Mile	1.97
Location	Water Side
Category	Earthen Levee
Item	Erosion / Bank Caving
Photo taken spring 2012, the erosion has encroached into the power pole.	
johngw_s_20120326_603.jpg

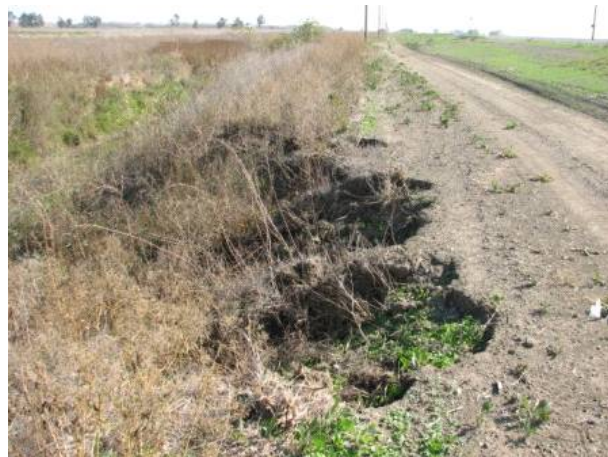
Levee Mile Report Line	7
Start Levee Mile	2.66
End Levee Mile	2.66
Location	Water Side
Category	Earthen Levee
Item	Erosion / Bank Caving
The erosion in the channel is starting to encroach into the toe road. Fall 2011	
johngw_s_20120313_576.jpg

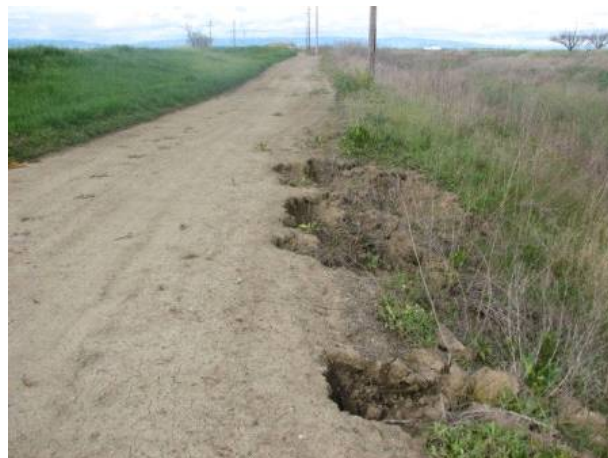
Levee Mile Report Line	7
Start Levee Mile	2.66
End Levee Mile	2.66
Location	Water Side
Category	Earthen Levee
Item	Erosion / Bank Caving
Photo taken spring 2012, the eroision encroaches into the toe road.	
johngw_s_20120326_604.jpg

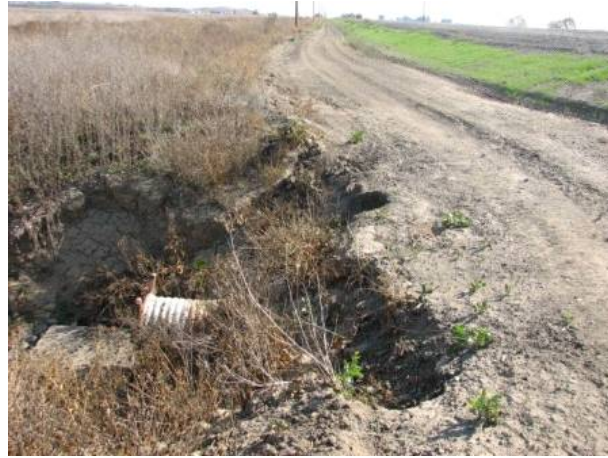
johngw_s_20120313_577.jpg

Levee Mile Report Line	8
Start Levee Mile	2.90
End Levee Mile	2.90
Location	Water Side
Category	Earthen Levee
Item	Erosion / Bank Caving

The slope around the discharge pipe is eroding the toe road. Rip rap could be placed around the pipe and re-sloped. Fall 2011
